## WAREHAM DAM INTERIM SPILLWAY REPAIRS

# Wareham Dam Interim Spillway Repairs

By Irfan Maan, M.Eng., P.Eng. (Stantec), Darryl Kenney, P.Eng. (Yukon Energy)

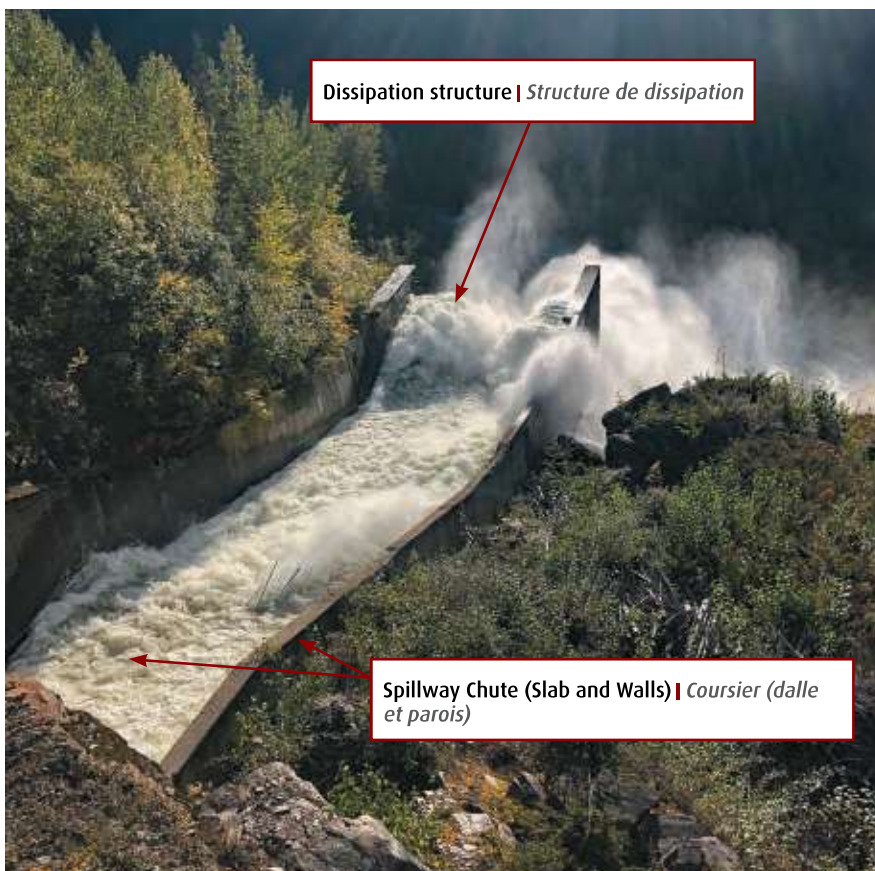
The hoarding and construction techniques implemented in the overtopping project did not provide for an adequate bond to the existing concrete, even with additional reinforcing bars drilled into the existing concrete. All these effects would unknowingly lead to a catastrophic failure during the

Labour Day weekend in 2020, as seen in Figure 2 on page 18.

As mentioned earlier, the root cause analysis indicated that the major cause of failure during the 2020 event was likely stagnant pressure. This pressure might have built up due to water ingress into the two layers of

new overtopping (2004 repair) concrete and old concrete (original construction in 1952) through unsealed expansion joints. The inadequate bond between new and old concrete due to poor construction practices and high concentrated flow conditions through one gate also contributed to the failure of the chute slab. The sealant in the expansion joints was deteriorated to the extent that it was not effective anymore. No waterstops were installed in the joints during 2004 repairs. These waterstops are great defence against water infiltration. The chute slab does not have a drainage system to dissipate uplift pressure. This stagnant pressure or hydraulic jacking is suspected to have caused structural failures at other chute spillways in North America as well, the most notable being the Oroville Dam spillway (Wahl and Frizell, 2020; Wahl, 2020).

Figure 2. 2020 Flood Event | Crue de 2020

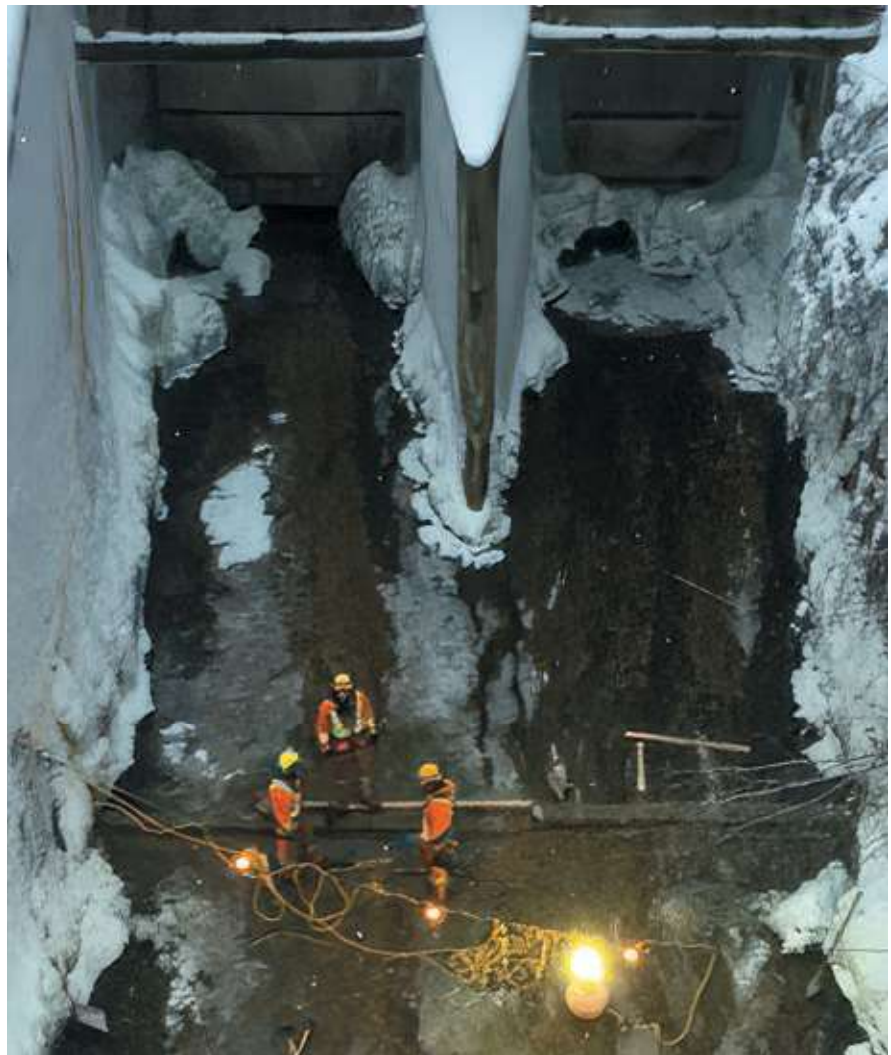
Figure 4. Work of Interim Repair in progress December 2020 | Travaux de réparations temporaires en cours en décembre 2020

To meet project schedule deadlines and site conditions, the project team came up with an innovative solution rather than using conventional concrete repair methods. The project team designed steel plates on rubber pads for all major voids and spalled areas with grouting afterwards instead of conventional concrete. Large plates with shear studs were installed over the deep voids, which were grouted from the top in the cold weather. The project team accepted the risk of low strength concrete due to some

The steel plates on rubber pads were installed on the joints to provide joint sealing. Hydrotite waterstops were also

installed in all open joints to prevent further water infiltration to the foundation below. Bevelled nuts with some torque were used to avoid loosening of the nuts and fatigue damage. Due to construction challenges and supply issues, the idea of countersunk nuts was dropped (see Figure 5 on page 21).
